Cite as: AIP Conference Proceedings 2094, 020016 (2019); <https://doi.org/10.1063/1.5097485>  
Published Online: 17 April 2019

# Fiber optic as embedded sensors to failure detection of beam green concrete

# Fiber Optic as Embedded Sensors to Failure Detection of Beam Green Concrete

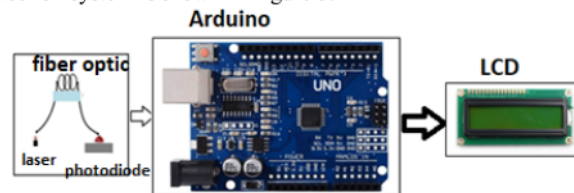
**FIGURE 3.** Block diagram failure detection system

This circuit will read a laser signal that passes through the fiber optics embedded in the beam concrete and detects the condition of the beam whether it is still good or has failed due to loading. The laser signal that passes through the fiber optic will be captured by the photodiode. The photodiode output voltage is inserted into Arduino. Arduino is programmed to be able to define a beam with embedded fiber optics that is given a load test whether or not it fails. Information about the condition of this beam is displayed in the LCD. The block failure detection system is shown in Figure 3.

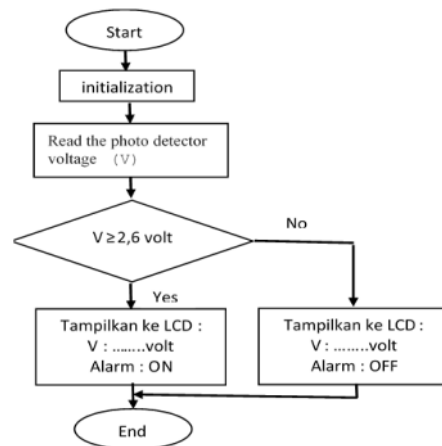
FIGURE 6. Arduino programming flowchart

The software design in question is for Arduino programming so that fiber optic output data can be displayed on the LCD. The flowchart of Arduino programming is shown in Figure 6.

Based on the results of data analysis, 2.6 volts is a voltage threshold where the beam starts to fail. Arduino programming is made according to the flowchart of Figure 6.
